# Allied-Axis

THE PHOTO JOURNAL OF THE SECOND WORLD WAR

# Contents

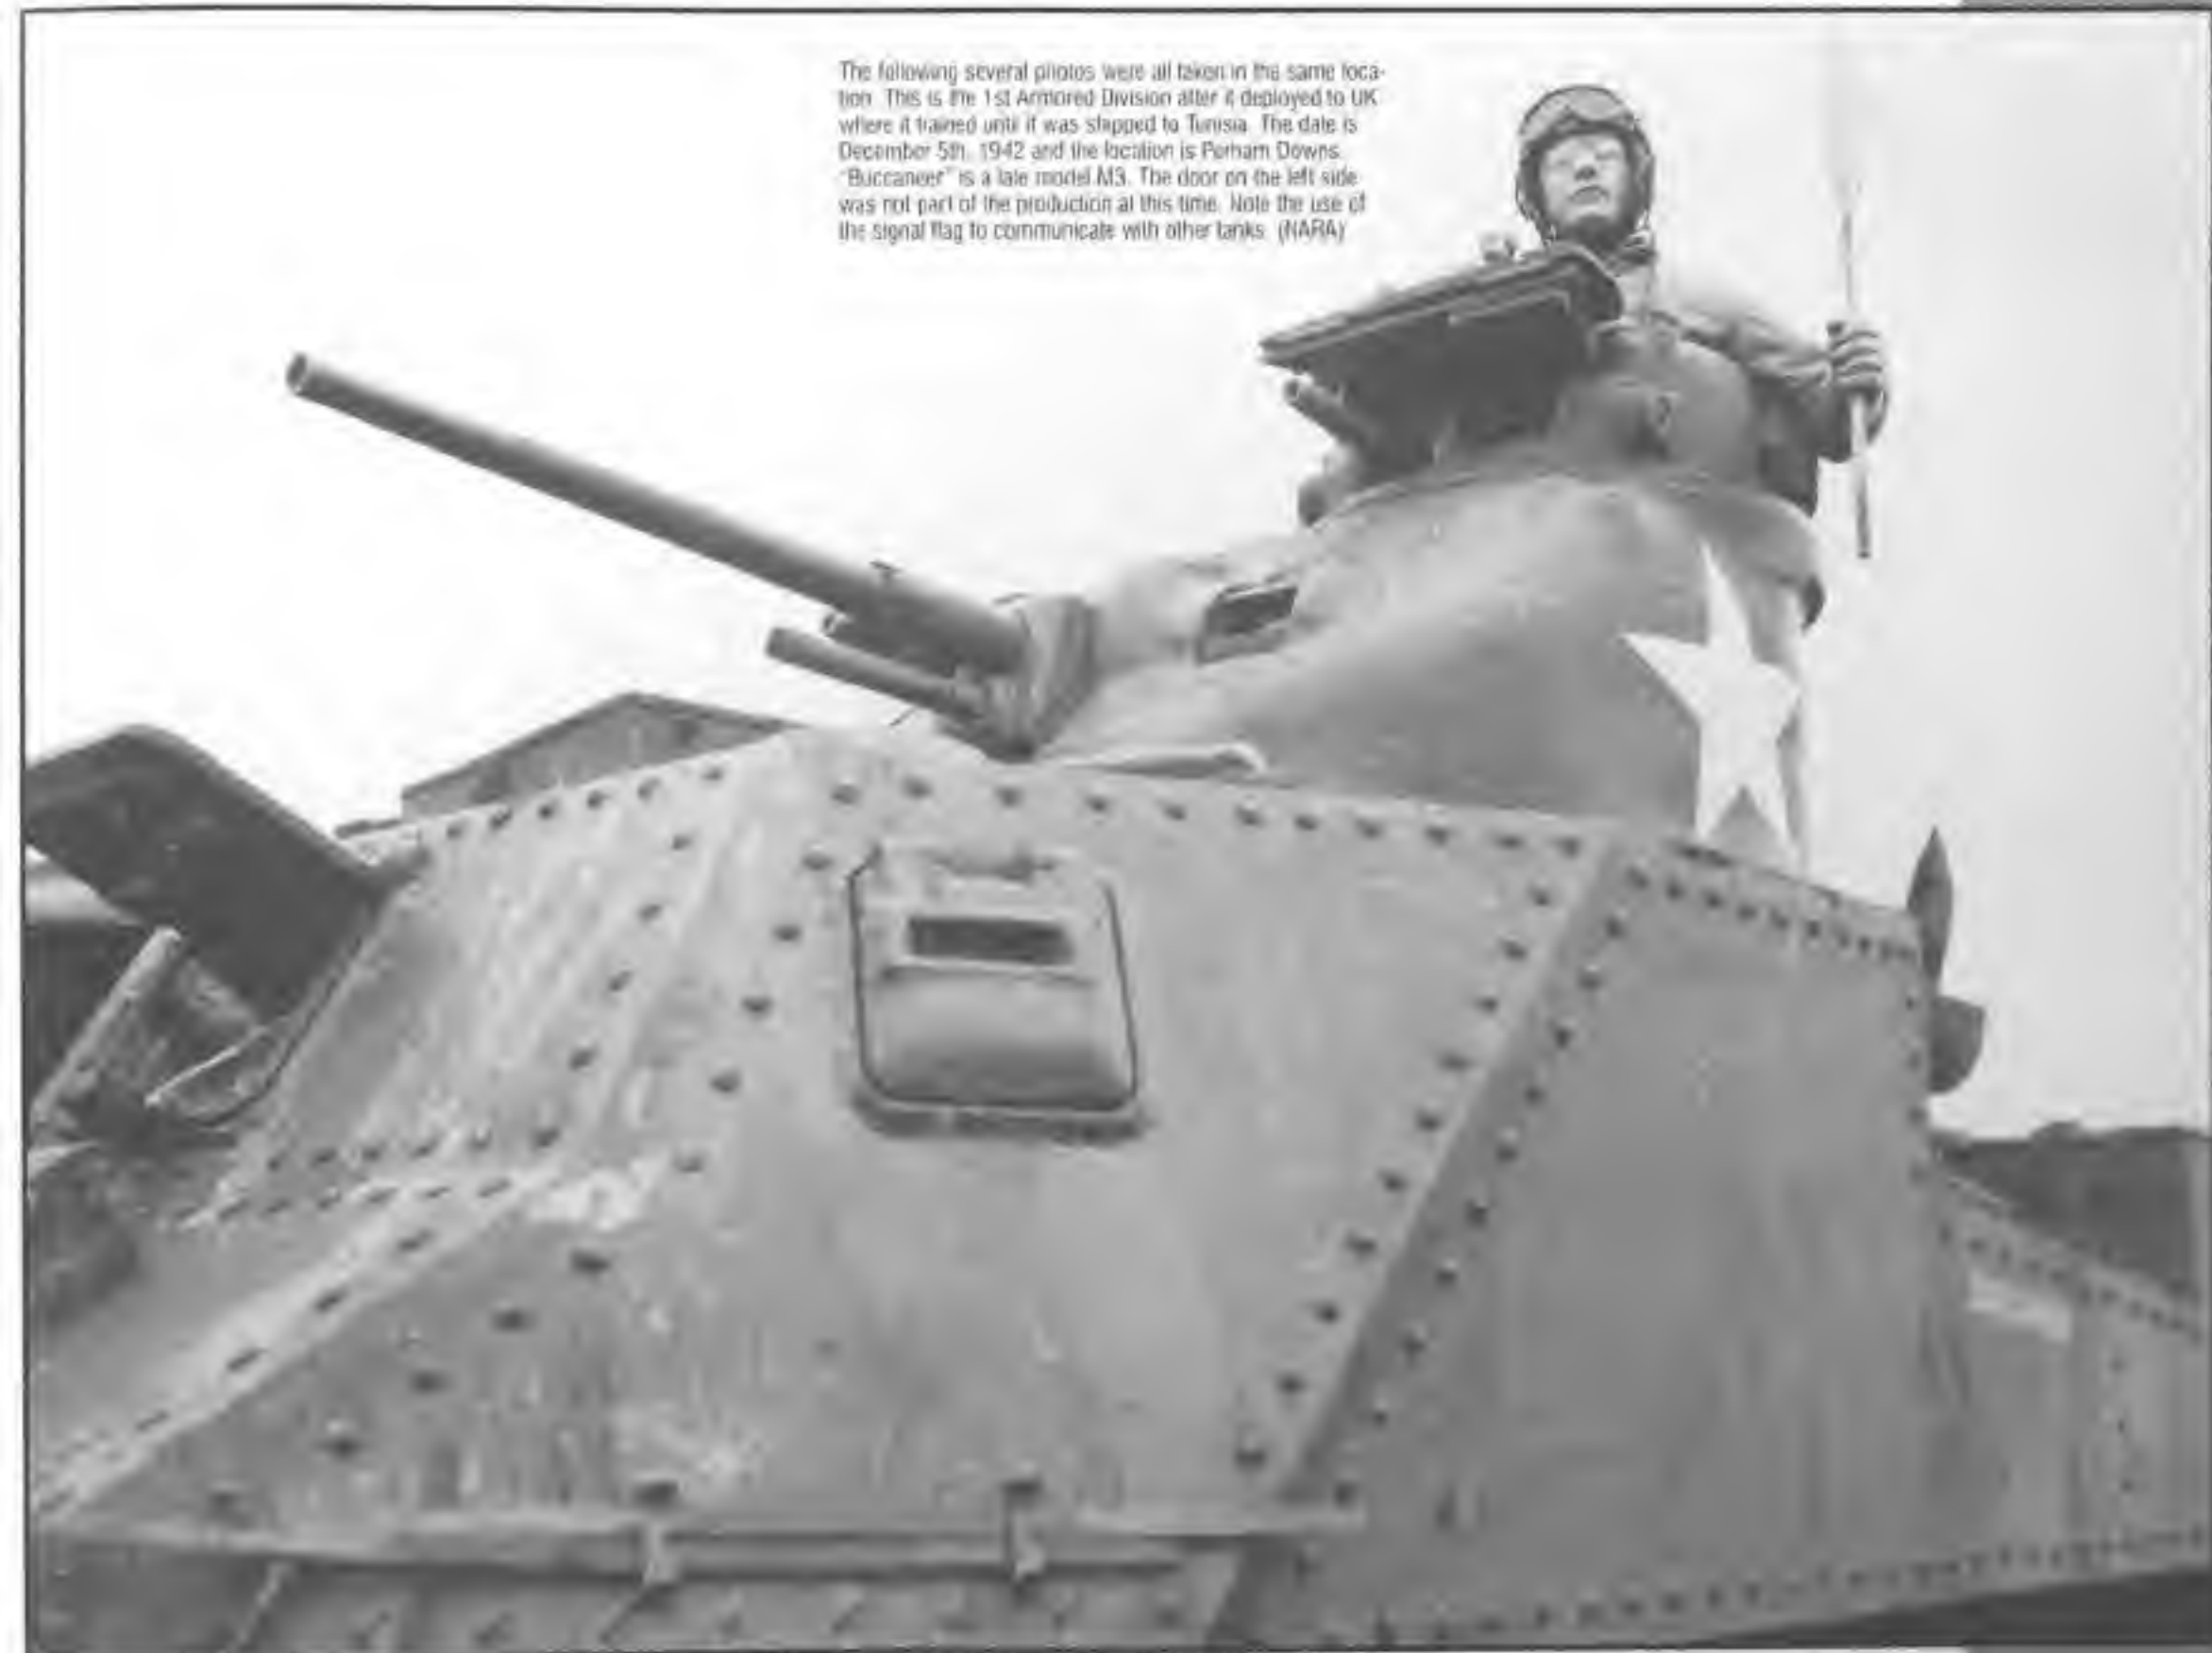
"Buccaneer" again. This time we can see that it too has the long-barrel 75mm M3 gun. Also, the extra storage box on the front plate for spare track links can be seen. Santa and his Thompson have made an appearance. This series of photos was taken just before Christmas in 1942. (NARA)

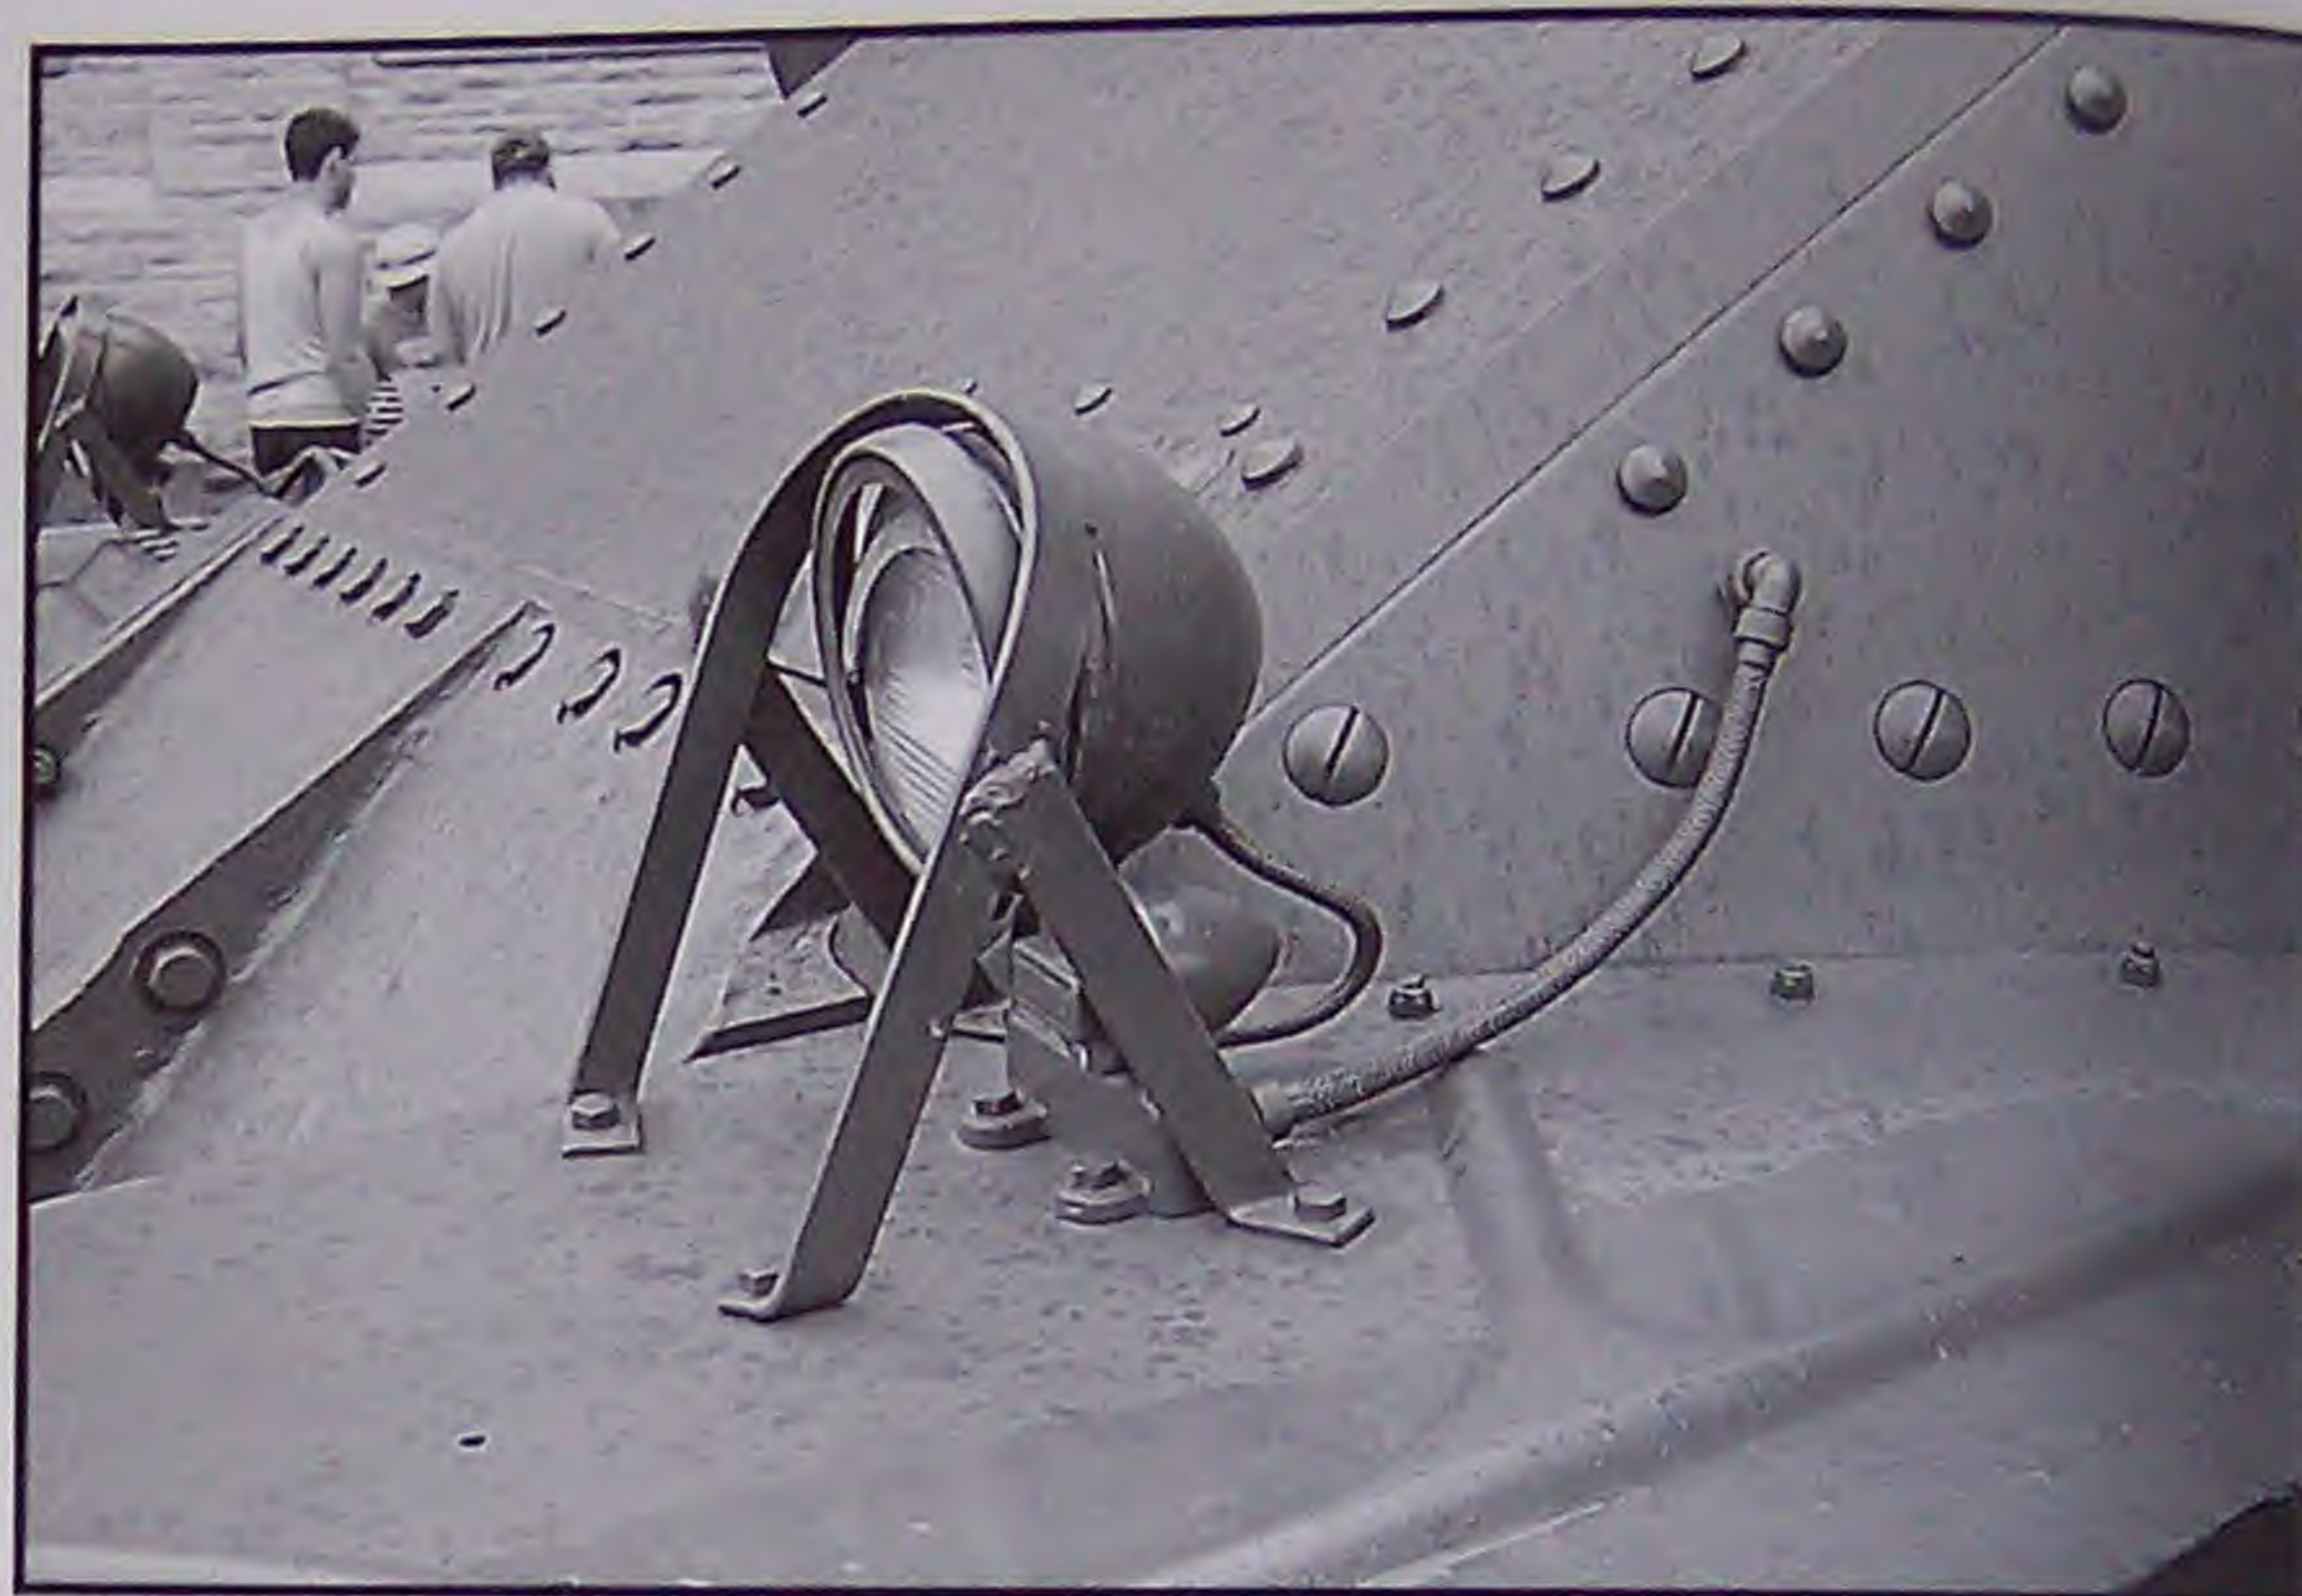
**Top left:** The dual machinegun openings in the front hull have been sealed with armored plugs. This view also gives an excellent perspective of the distinctive three-piece transmission housing. **Top right:** The left front fender and headlight wiring detail. The light appears to be a replacement, as it does not fit its housing properly. Note how the corner of the transmission housing is chamfered. **Above left:** An

overall view of the cast housing for the 75mm gun on the right side of the tank. The right fender detail can also be seen here. Although the mounts are present, the machinegun tripod and ax head are both missing. **Above right:** The early "fancy" style version of the drive sprocket would have been common on this tank. Perhaps it was switched to this later style due to damage and/or wear.

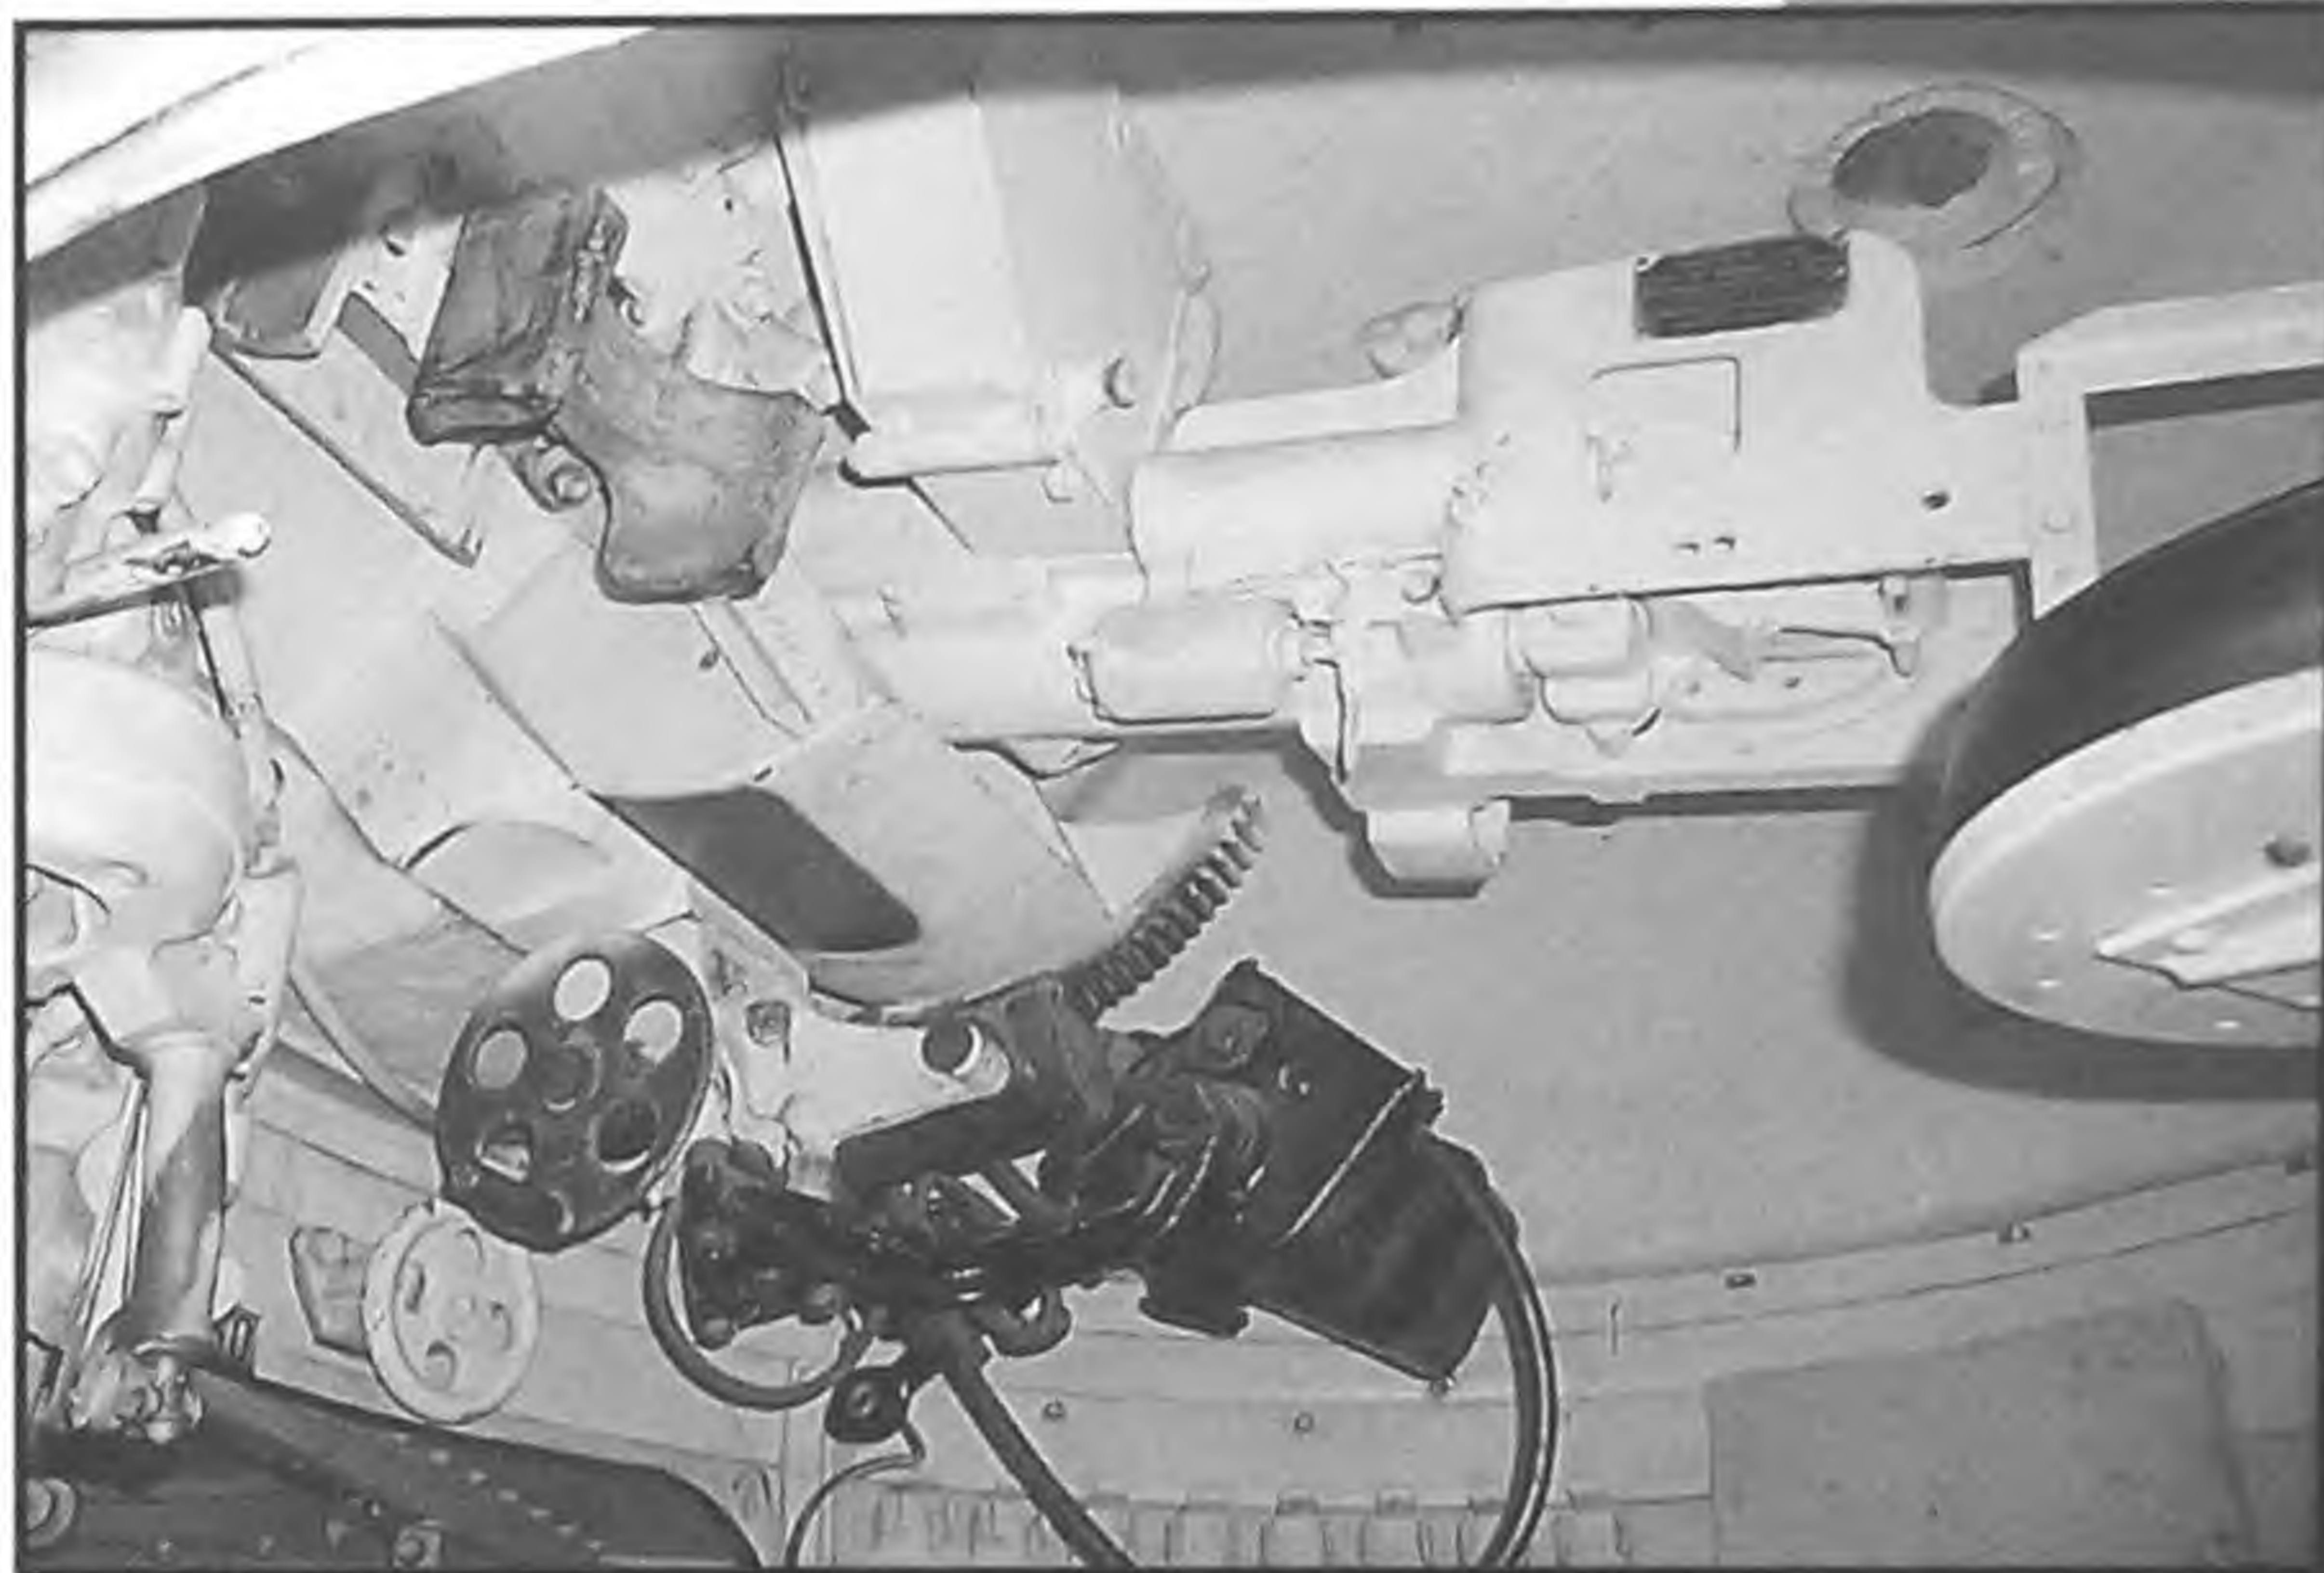
**Top left:** The top machinegun turret has been removed and replaced with a Sherman style split hatch. The casting texture on the turret and the 75mm gun mount also are evident in this photo. **Top right:** Looking up at the 37mm gun in the turret, the breech and the elevation wheels can clearly be seen. The gunner's sight is missing on this example. **Above left:** This Lee uses the later canister style exhaust

system seen on the Sherman. The large double access doors are also seen on several types of Shermans. **Above right:** This is a good view of the original type of suspension called the Vertical Volute Suspension System or VVSS with the return roller centered over the open-spoke roadwheels. The rubber on the roadwheels has taken a considerable beating over the years.

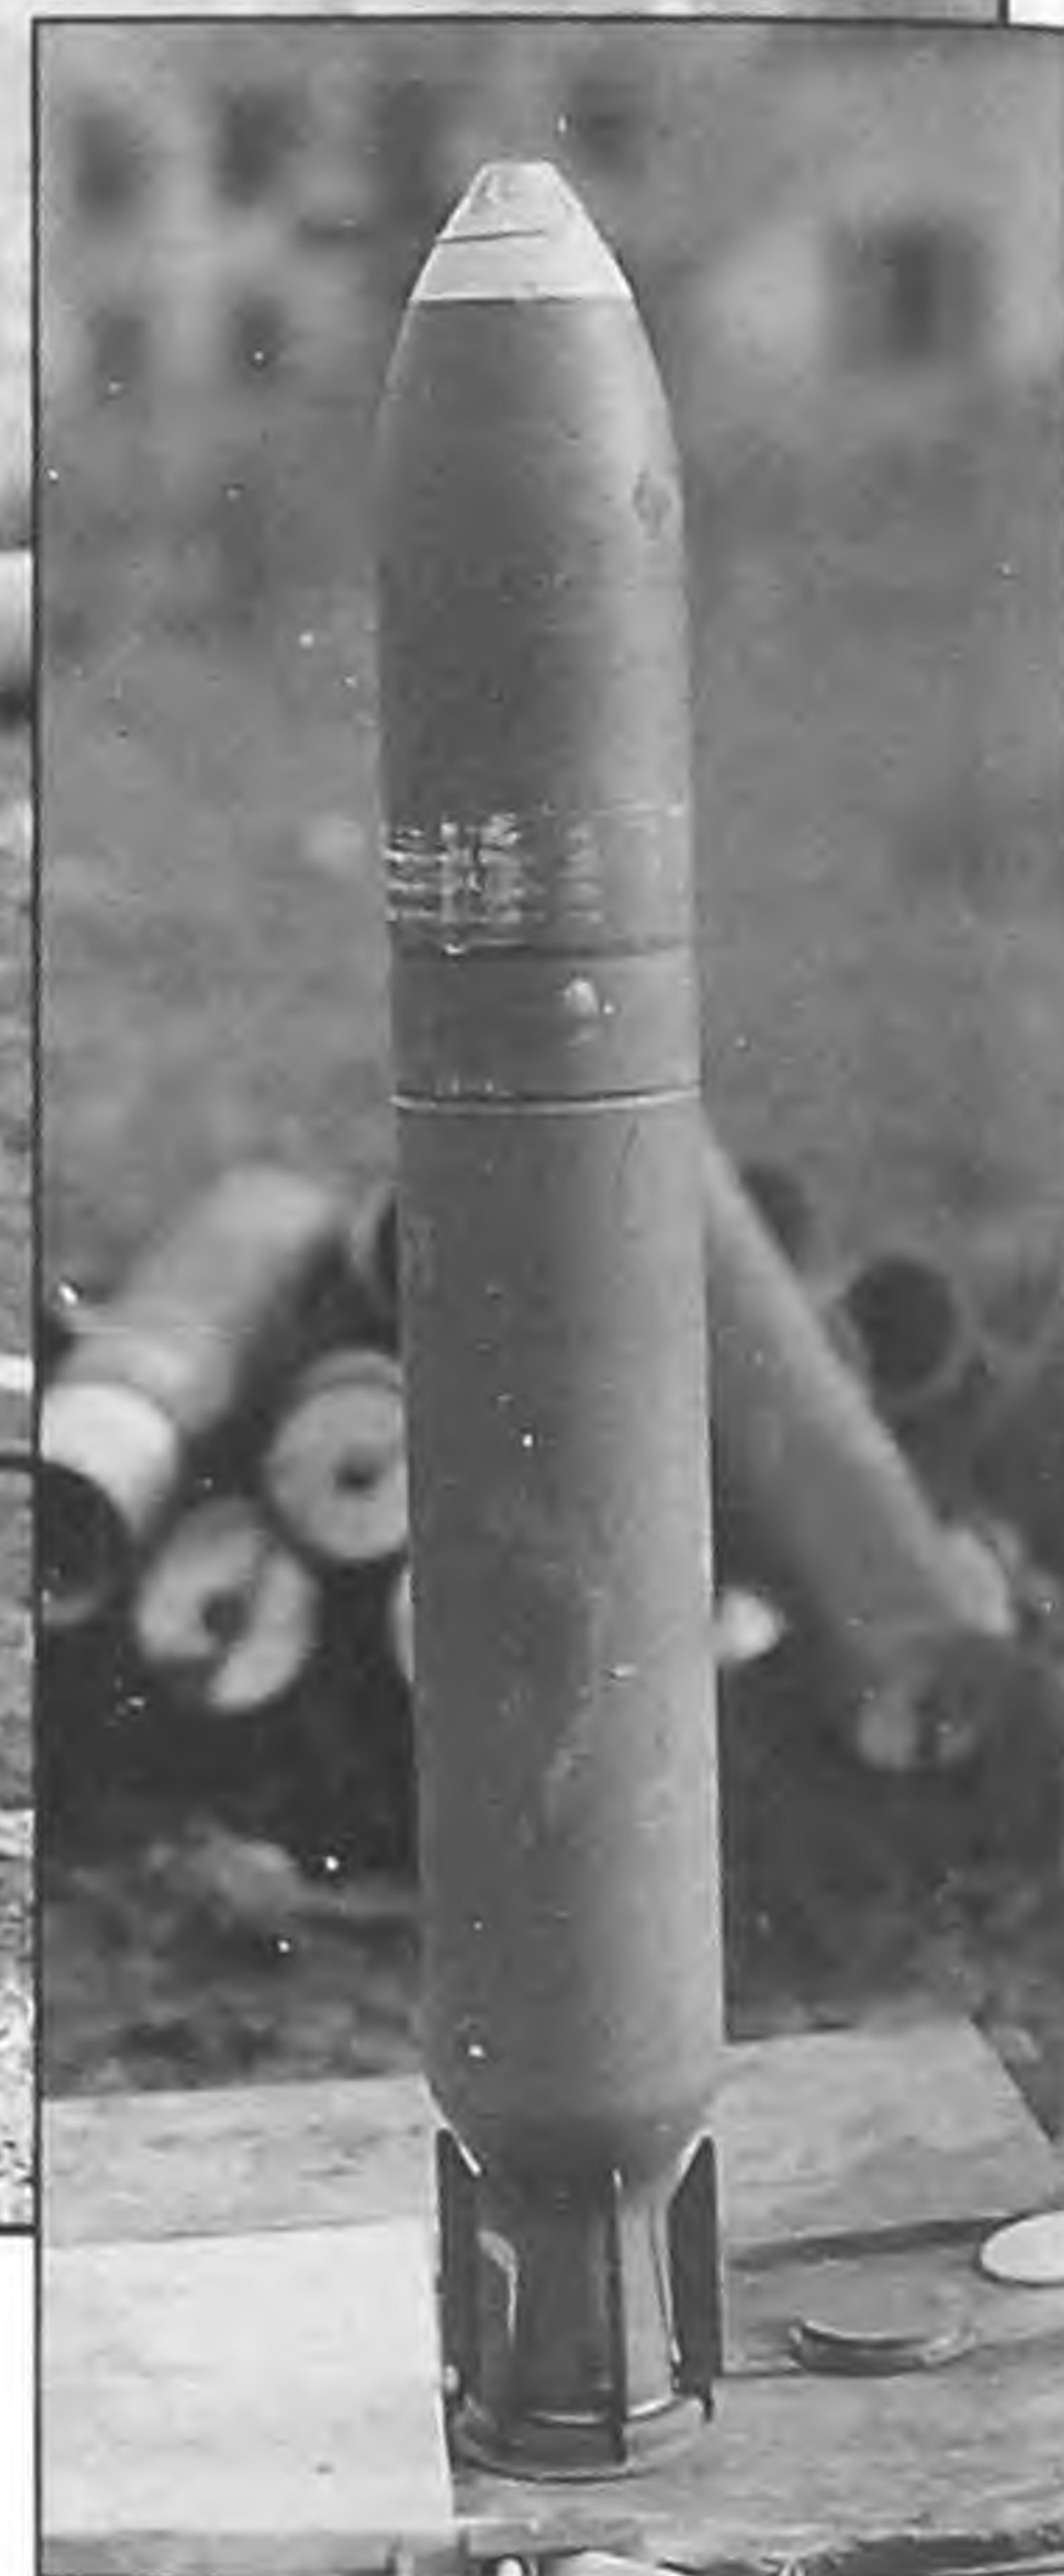
**Above:** a crew is setting the fuse on the rockets. There were four different types of rocket, M8, M8A1, M8A2 and M8A3. There were only minor differences in the various rounds and each was progressively more effective. These rockets each weighed approximately 38 pounds and had a 15-pound HE filling

warhead. The range of the rocket was approximately 4,000 yards. **Right:** The M8 4.5-inch round was a fin-stabilized rocket. The fins open up after the rocket has left the tube. The fiber containers can be seen in the background. (NARA)

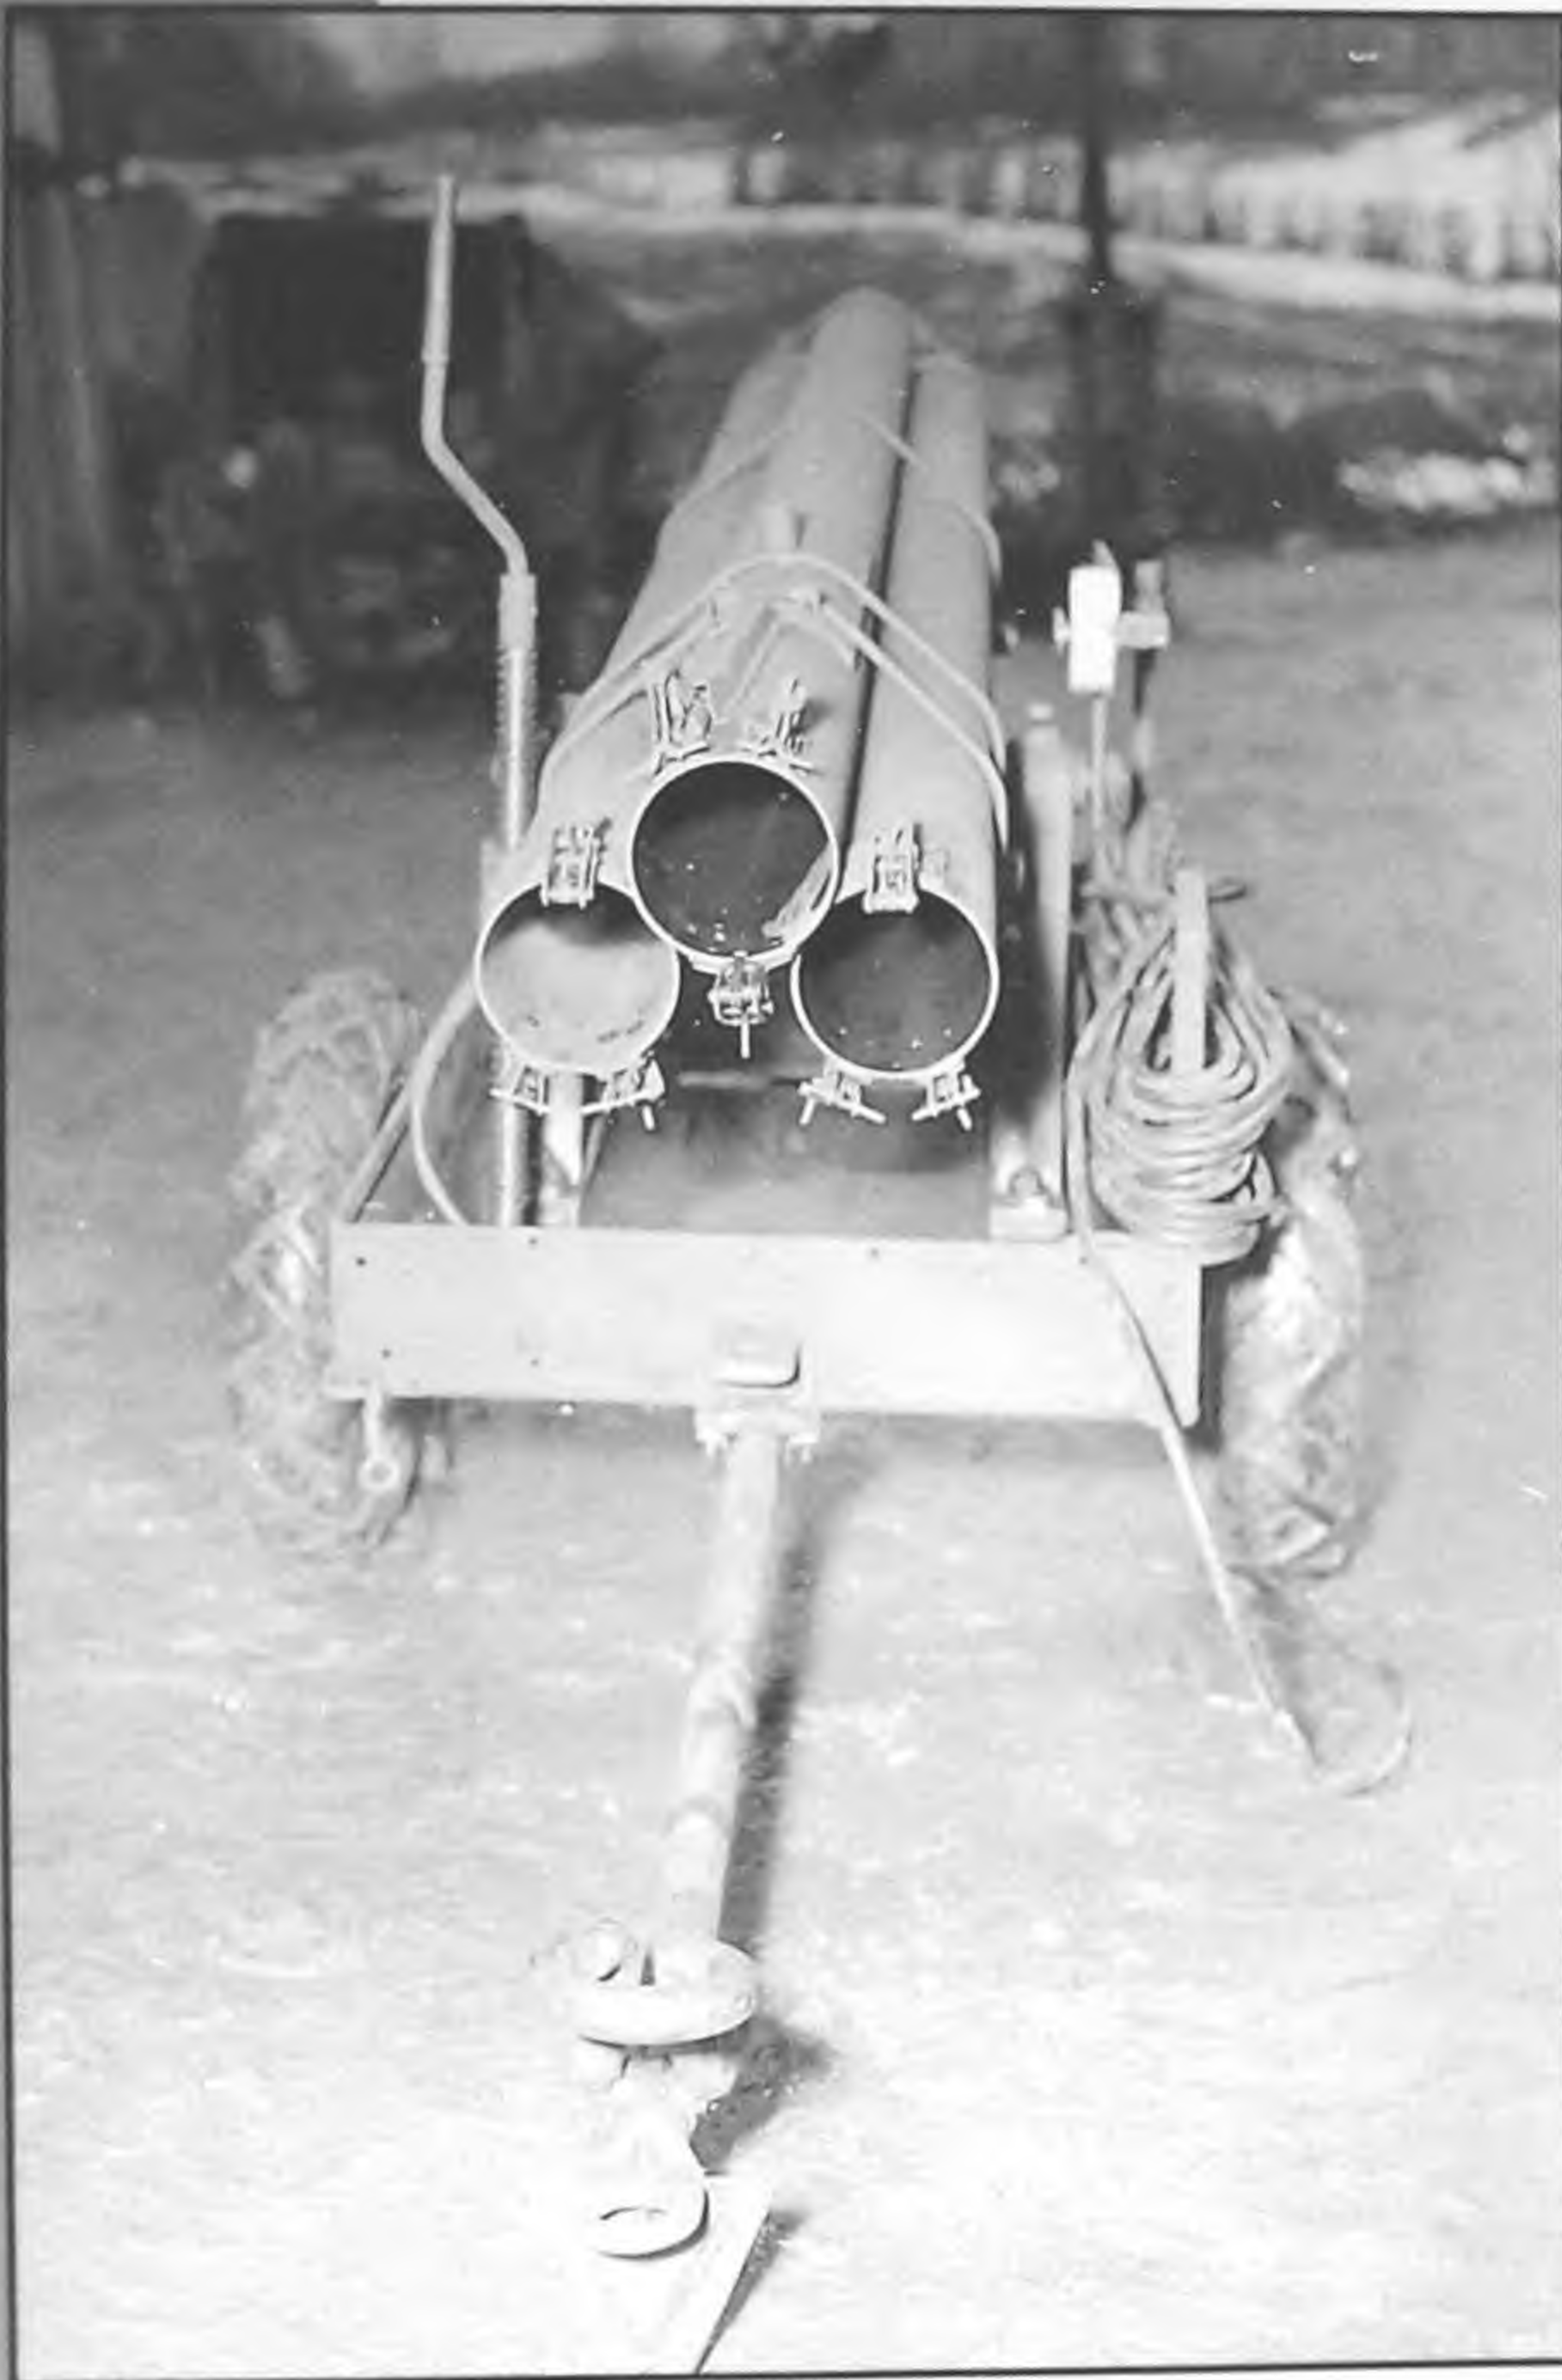
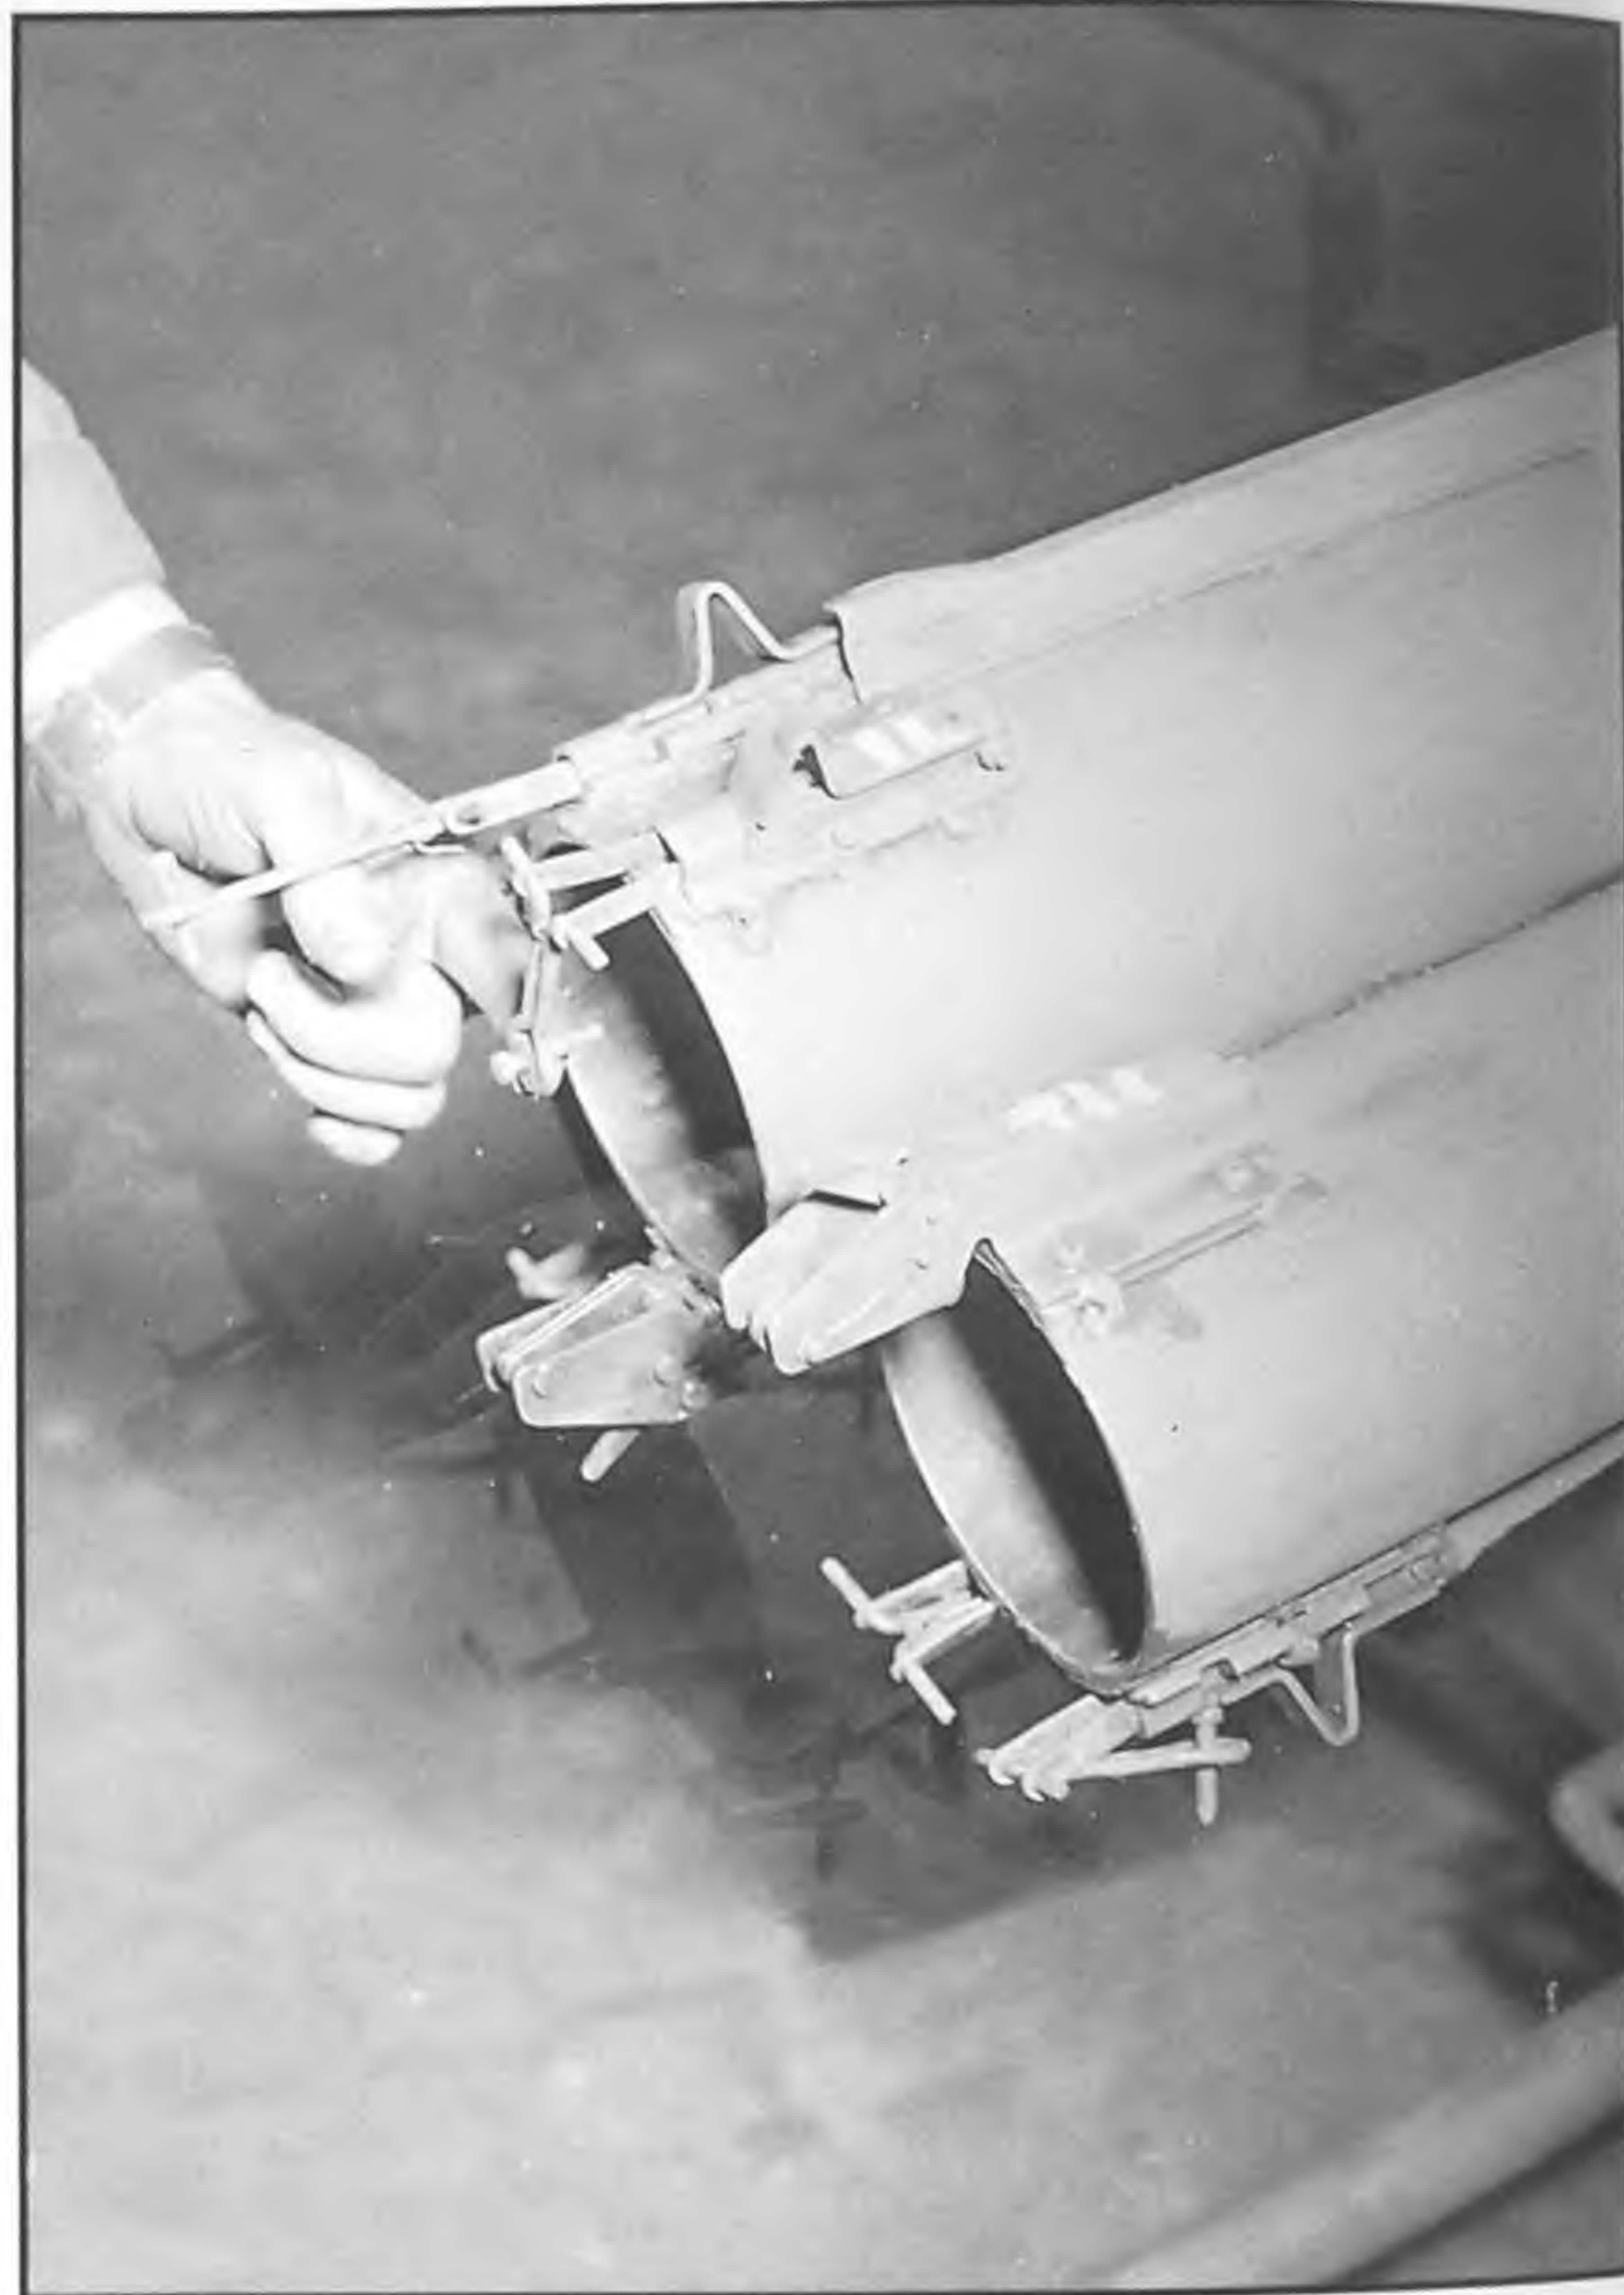
These two photos are excellent illustrations of the basic M14 steel launcher array. This was the initial configuration of the experimental mount, with the array simply placed on an improvised trailer. The only thing missing here is the under wing mounting brackets. The rockets could be fired all at once or singly when mounted to the wing of an aircraft, but it is unclear if this function was enabled on this ground-mounted version. Note the electrical wire coiled around the trailer. The shot above provides a close-up of the firing mechanism. (NARA)
